ADKINS ARBORETUM  
*A Chesapeake Native Garden*

**REQUEST FOR BIDS  
FOR  
Adkins Arboretum LADRT 1601  
Bridge Deck Repair**

**Adkins Arboretum** is soliciting bids for **the repair of five woodland bridges**. These woodland bridges integrate our woodland paths together over Blockston Branch and sustain primarily foot traffic, though some (as noted below) support vehicles. Currently, these bridges or components of them have become degraded due to weather.

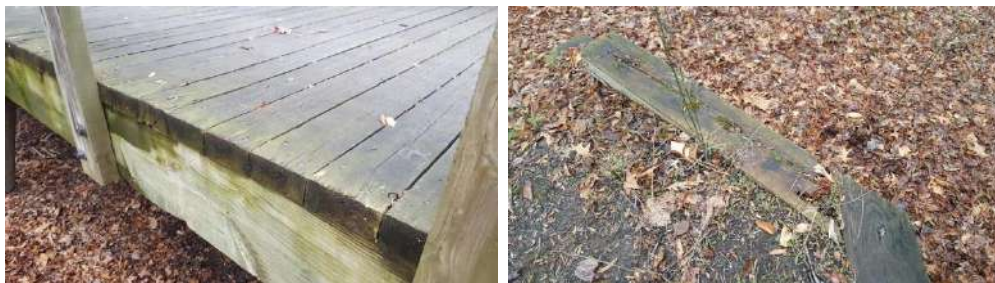
**BRIDGE #1 (first bridge at forest entrance)**

- Description: vehicle rated bridge, requires 3x6 planks, #1 grade southern yellow pine treated.
- Replace 10 planks that are slightly rotted or soft
- Replace two top retaining wall timbers (6x8's) that are rotting out (one on each side of the bridge - 8 board feet)

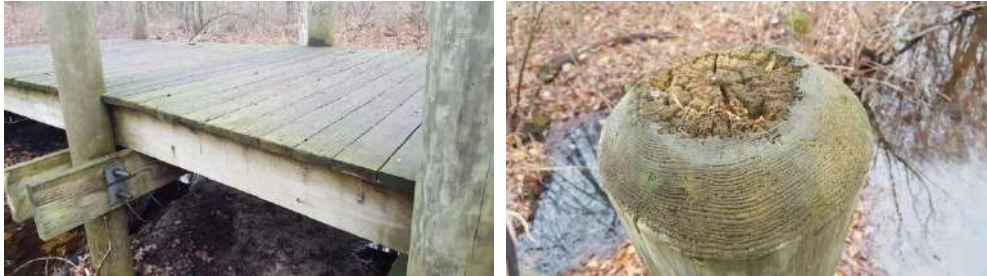
## BRIDGE #2

- Description: not vehicle rated, 2x6 planks, #1 grade southern yellow pine treated.
- Replace all bridge planks
- Dimensions: 9ft wide x 24ft long
- Top rot on the pilings-cut off top 4 inches and replace with copper caps (8 pilings)

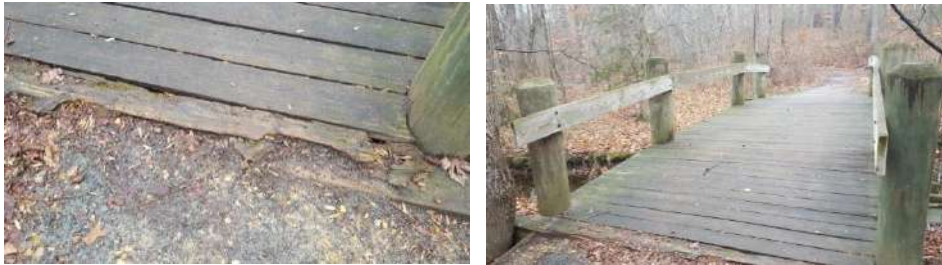
## BRIDGE #3

- Description: not vehicle rated, 2x6 planks, #1 grade southern yellow pine treated.
- Dimensions 9 ft wide x 24 ft long
- Replace 10 planks that are slightly rotted or soft
- If there is enough funding, could replace all planking, but not urgent
- Top rot on the pilings-cut off top 4 inches and replace with copper caps (8 pilings)

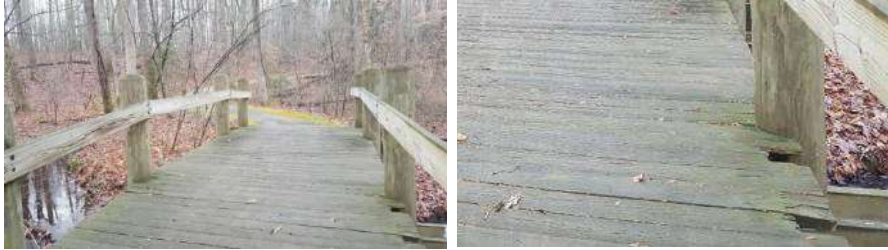
#### BRIDGE #4

- Description: not vehicle rated, 2x6 planks, #1 grade southern yellow pine treated.
- Dimensions 9 ft wide x 24 ft long
- Replace all bridge planks
- Top rot on the pilings- cut off top 4 inches and replace with copper caps (8 pilings)

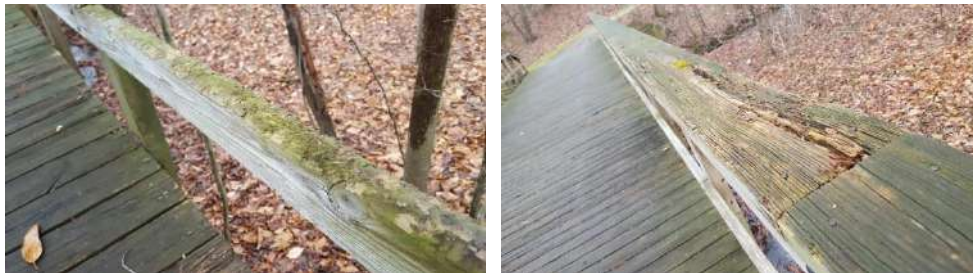
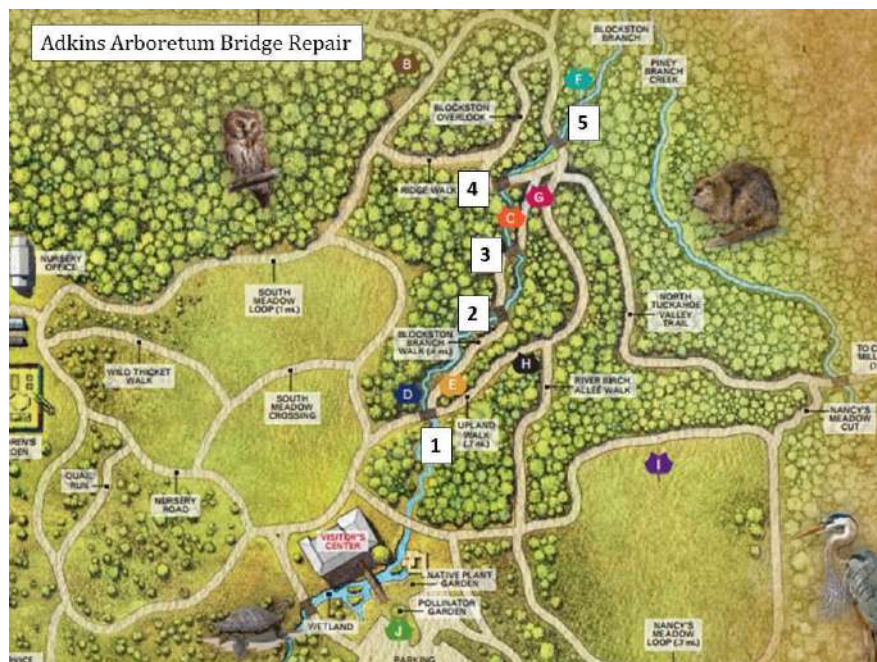
#### BRIDGE #5

- Description: vehicle rated bridge, requires 3x6 planks, #1 grade southern yellow pine treated.
- Dimensions 10 ft wide x 65.5 ft long
- Replace 25 feet of the top retaining wall boards (6x8's) on far side of bridge
- Replace all 3x6 bridge planks
- Replace all top boards(2x8's) on the hand rails
- If money allows, replace the mid-level 2x4 railings (squirrel damage)
